## Analyst®

HotFix3  
Version 1.6.3

### Fixed Issues

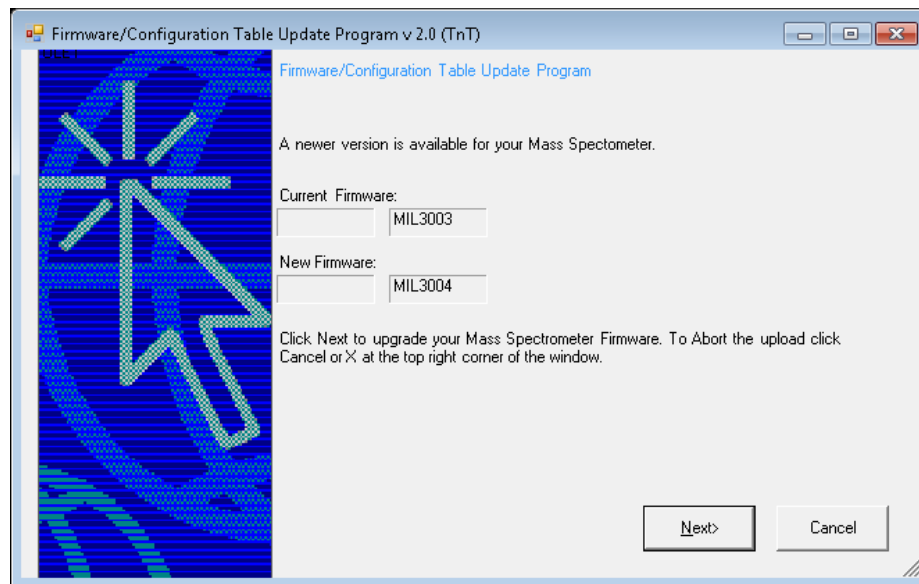
The ConfigUpdater program opens and then identifies the new firmware version to be installed.

**Note:** The ConfigUpdater utility will reset the mass spectrometer system controller. This is normal and is required by the update process.

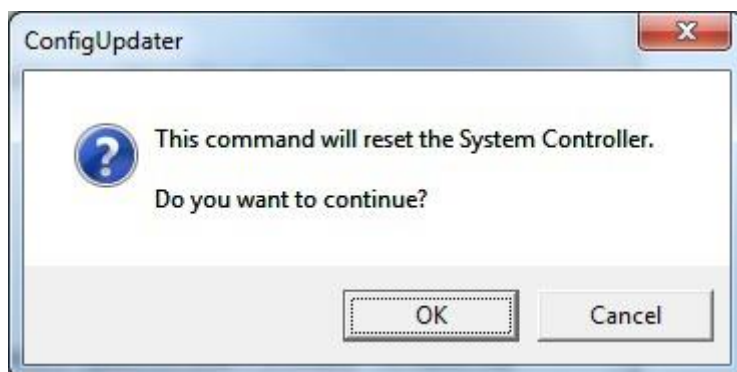
4. When the firmware upgrade is **partially done**, the following message is shown. **Do not click OK until the 10 minutes indicated in step 3 have elapsed.**
